FAILURE MODES OF AN ALUMINA-BASED MACHINING CERAMIC

Thesis submitted to the Council for National Academic Awards
in Partial Fulfilment of the requirements for
The Master of Philosophy Degree.

Middlesex Polytechnic
Resource Centre for Engineering
Science and Mathematics.

September 1979.

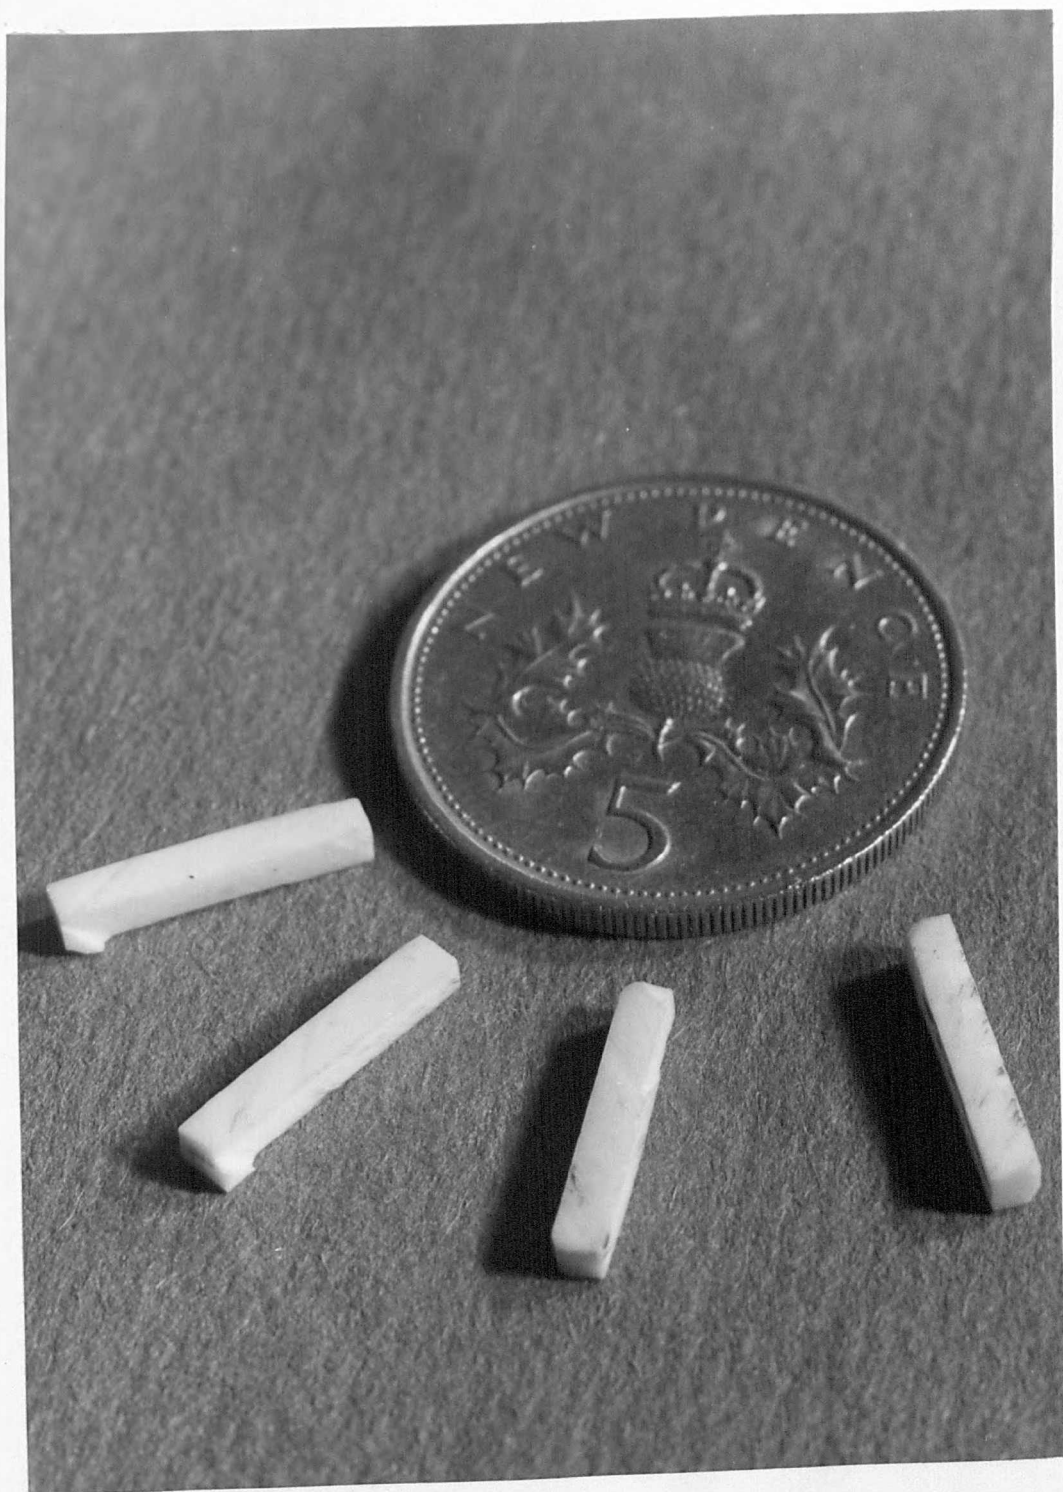
Fig.2.3.3(a). Alumina Prisms.
Cut from tool tips for stiffness tests.

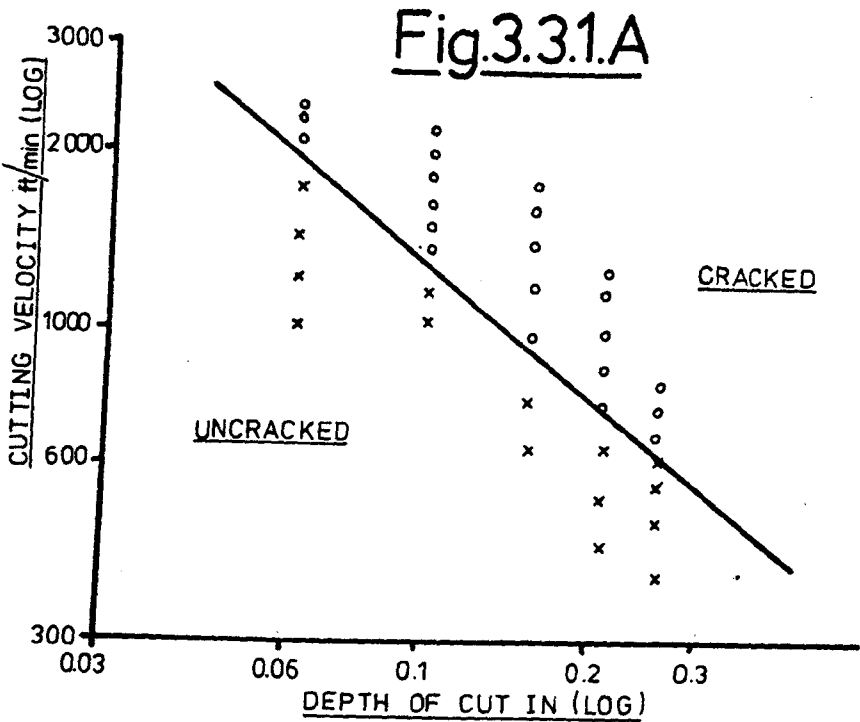
"COMB-CRACK" THRESHOLD OBTAINED BY MILES AT
CONSTANT FEED RATE OF 0.006 in/rev.

3.3.1 Lathe tests were carried out in an attempt to induce "comb" cracking along the cutting edge of the alumina tool tips, based upon the work carried out by Miles¹¹, fig.3.3.1(a). The tool tips, tool-holder and test piece material were all of the same types used by Miles in order to reproduce as closely as possible similar machining conditions. Cutting velocities of between 500 and 2500 ft/min (150 to 760 m/min), were related to depths of cut ranging from 0.05 to 0.25 in

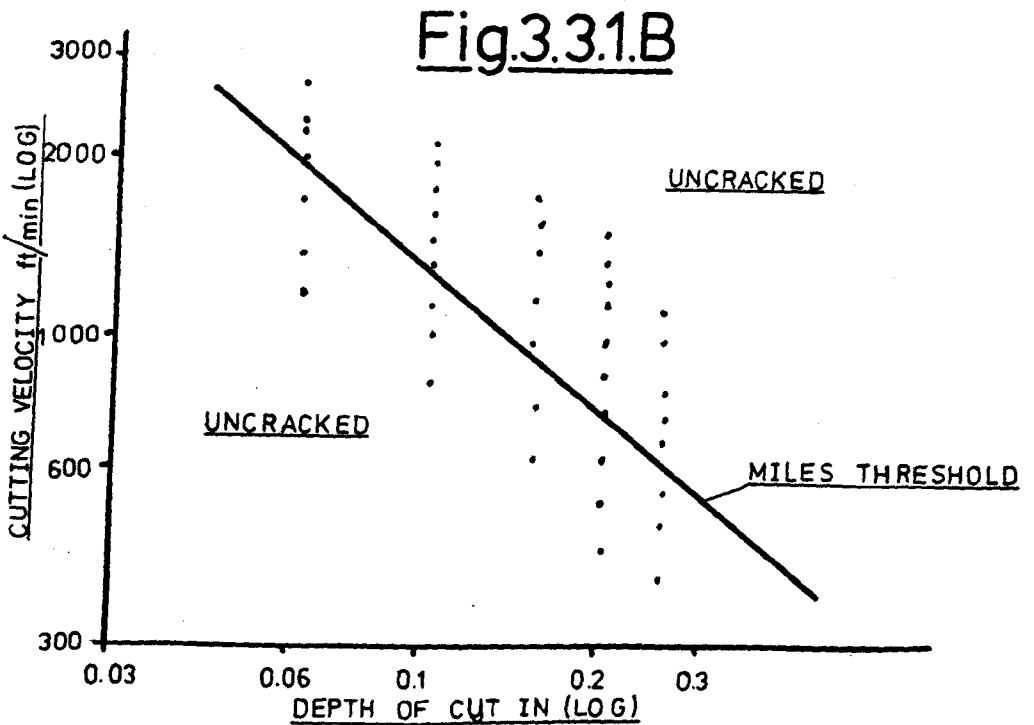
Fig. 3.32.

GRAPH COMPARING MACHINING PARAMETERS WITH MILES-FEED
RATE CONSTANT AT 0.005 in/rev. NO 'COMB' CRACKS OBSERVED.

(1.25 to 6.25 mm) with a constant feed rate of 0.005 in/rev (0.125 mm/rev), fig.3.3.1(b). No "comb" cracks were observed, even at metal removal rates at over twice the Miles threshold.

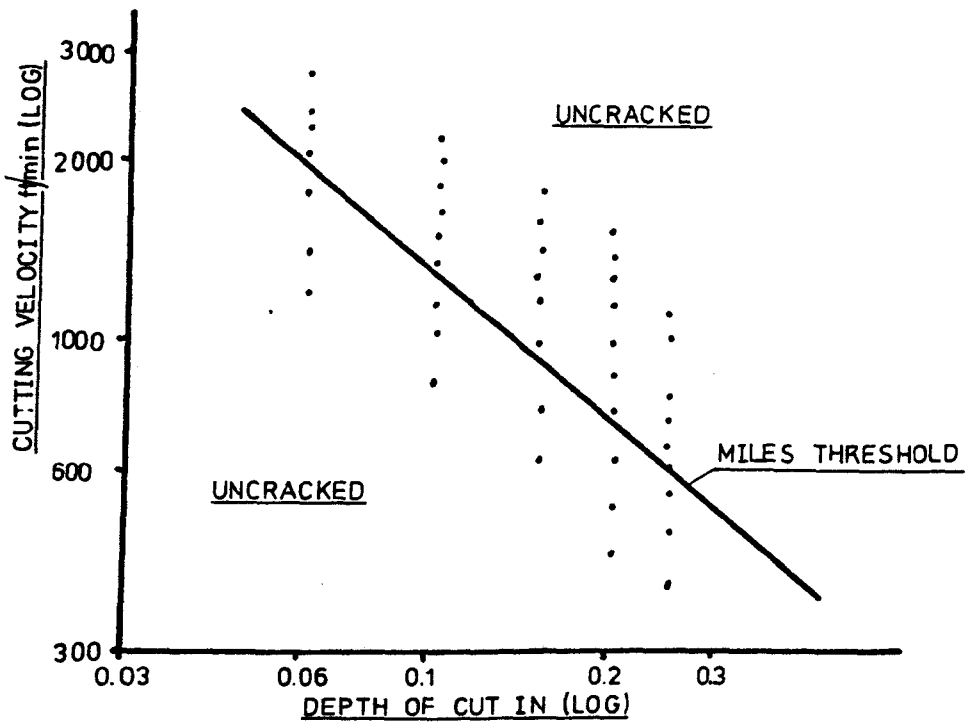
Fig 3.3.3.

GRAPH COMPARING MACHINING PARAMETERS WITH MILES
NO COMB-CRACKS OBSERVED. FEED RATE CONSTANT AT
0.010 in rev. TWICE THE RATE USED IN THAT OF FIGS
3.31A AND 3.31B.

3.3.2 The above tests were repeated with the feed rate doubled to the value of 0.010 in/rev (0.25 mm/rev). These tips also failed to exhibit "comb" cracks, fig.3.3.2.

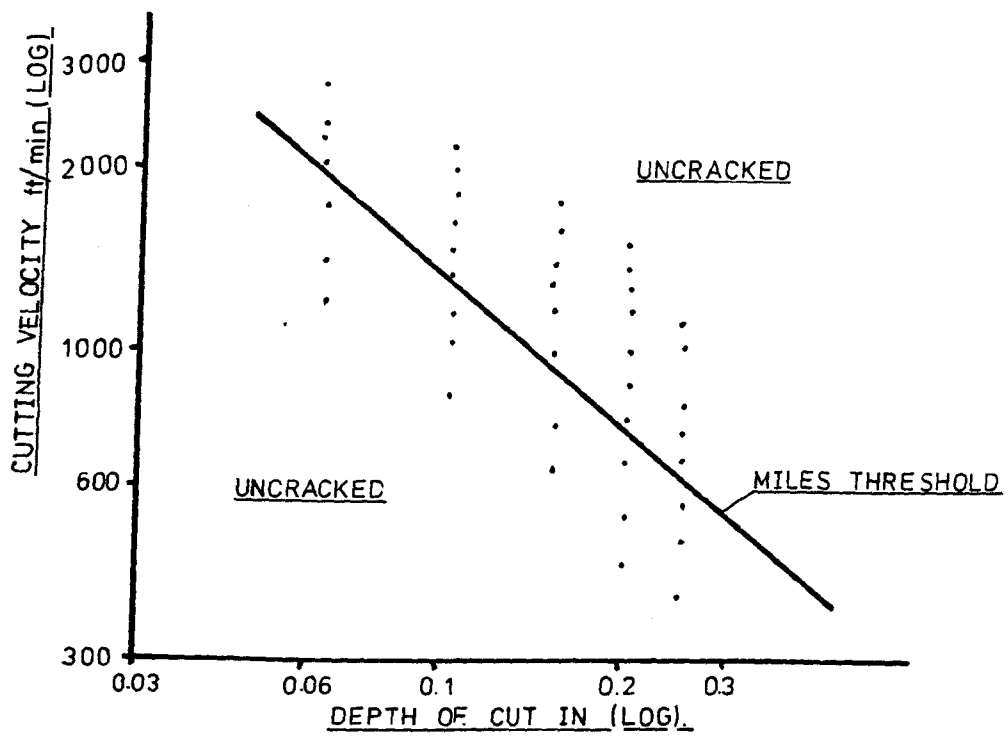
Fig 3.3.4.

GRAPH COMPARING MACHINING PARAMETERS WITH MILES - FEED RATE CONSTANT AT 0.010 in/rev. CHIP BREAKER POSITIONED IN EACH OF FOUR POSSIBLE LOCATIONS. NO 'COMB' CRACKS OBSERVED.

3.3.3 Exhaustive lathe tests at machining rates above the "comb" crack threshold established by Miles, (see fig.3.3.1(a)), were repeated for each of the four possible chip-breaker positions at 0.010 in/rev (0.25 mm/rev) feed rates. No "comb" cracks were observed, fig.3.3.3.

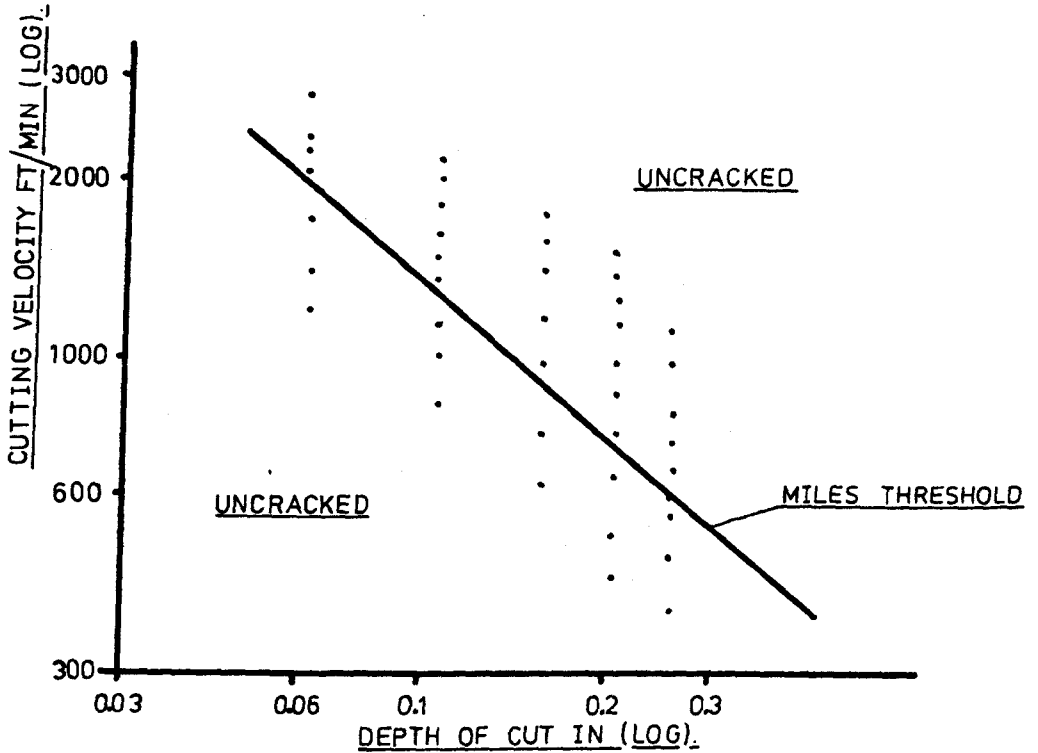
Fig. 3.3.5.A

GRAPH COMPARING MACHINING PARAMETERS WITH PEKELHARING AND MILES. EACH TOOL TIP CORNER USED TWICE AT FEED RATES OF 0.005 AND 0.010 in/rev. WITH CHIP BREAKER IN VARIOUS POSITIONS. NO 'COMB' CRACKS OBSERVED.

3.3.4 Pekelharing¹⁰ stated that "comb" cracks occurred during the first cut and only became visible when a second cut was taken with the same tip due to the fact that "steel was forced into them". Therefore, some selective lathe tests covering the entire range of cutting velocities, depths of cut, feed rates and chip breaker positions already used, were repeated in an attempt to reproduce Pekelharing's observations. These tips also failed to exhibit any cracking, fig.3.3.4.

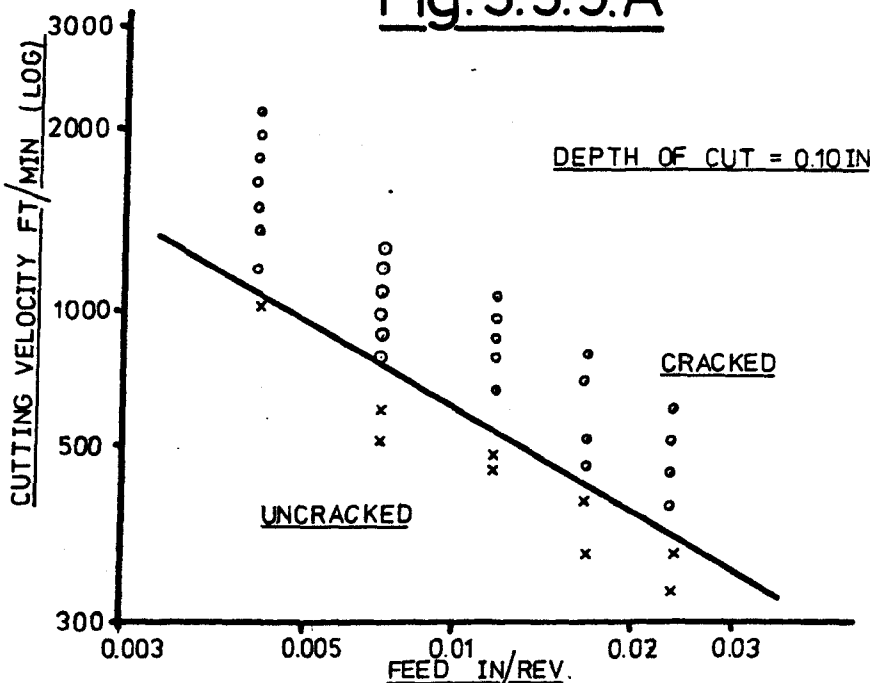
Fig. 3.3.5.B

'COMB' CRACK THRESHOLD OBTAINED BY MILES AT CONSTANT DEPTH OF CUT.

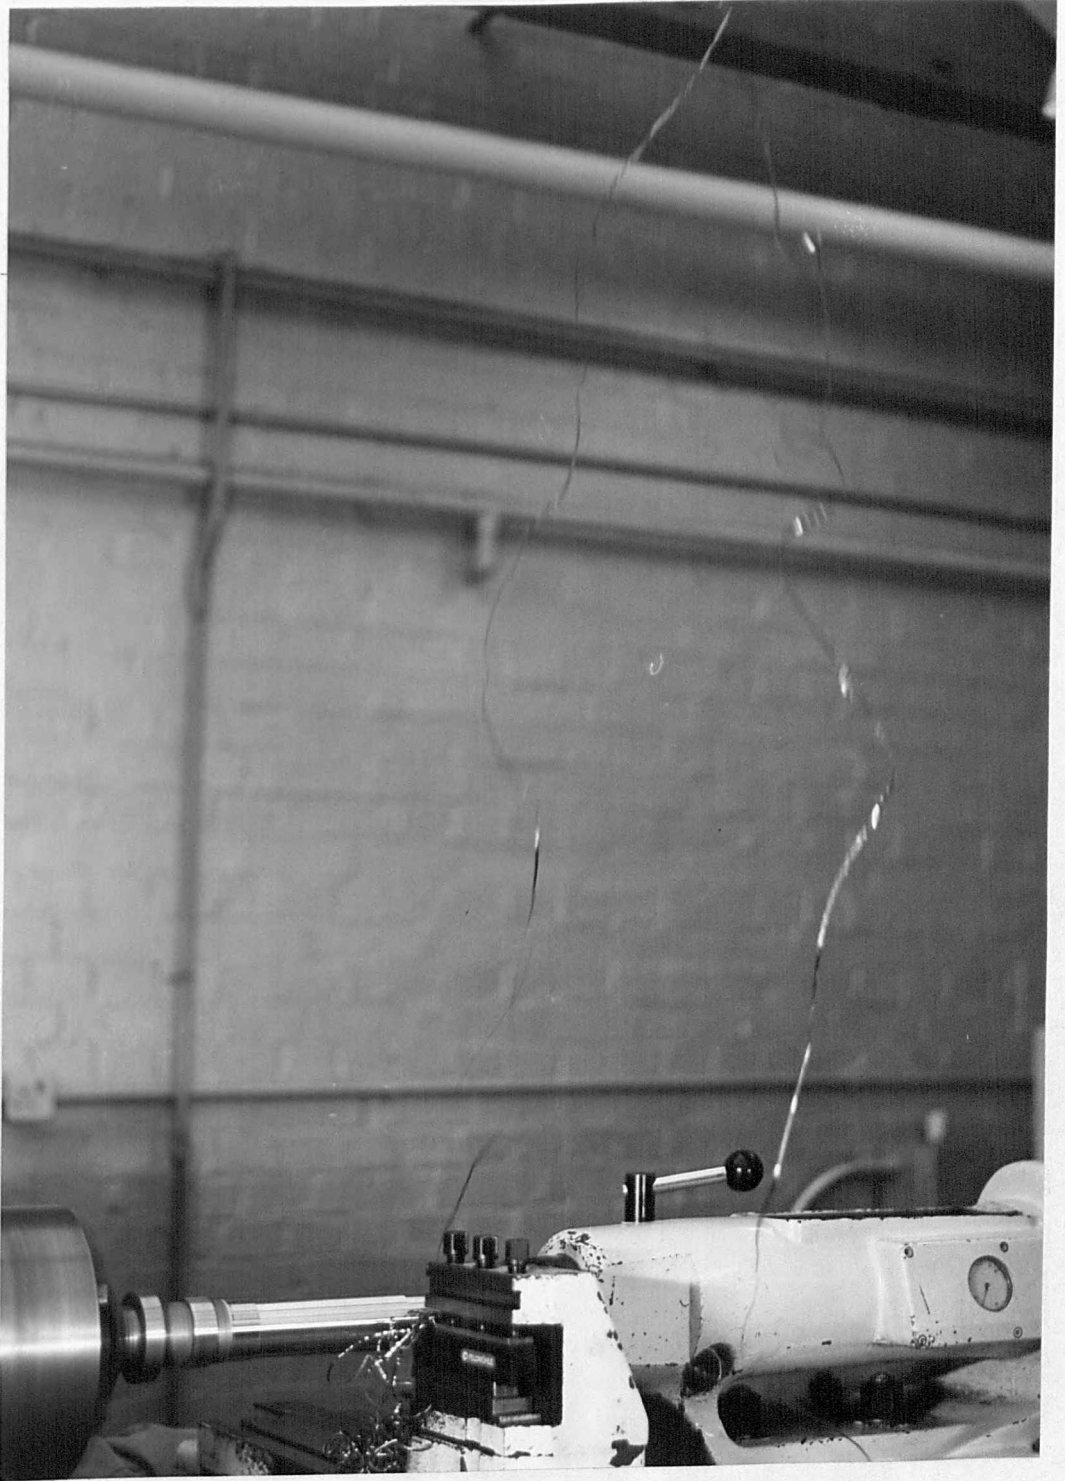
Fig.3.3.8. Swarf behaviour at cutting speed of 4500 ft/min with depth of cut 0.05 in and feed rate of 0.005 in/rev.

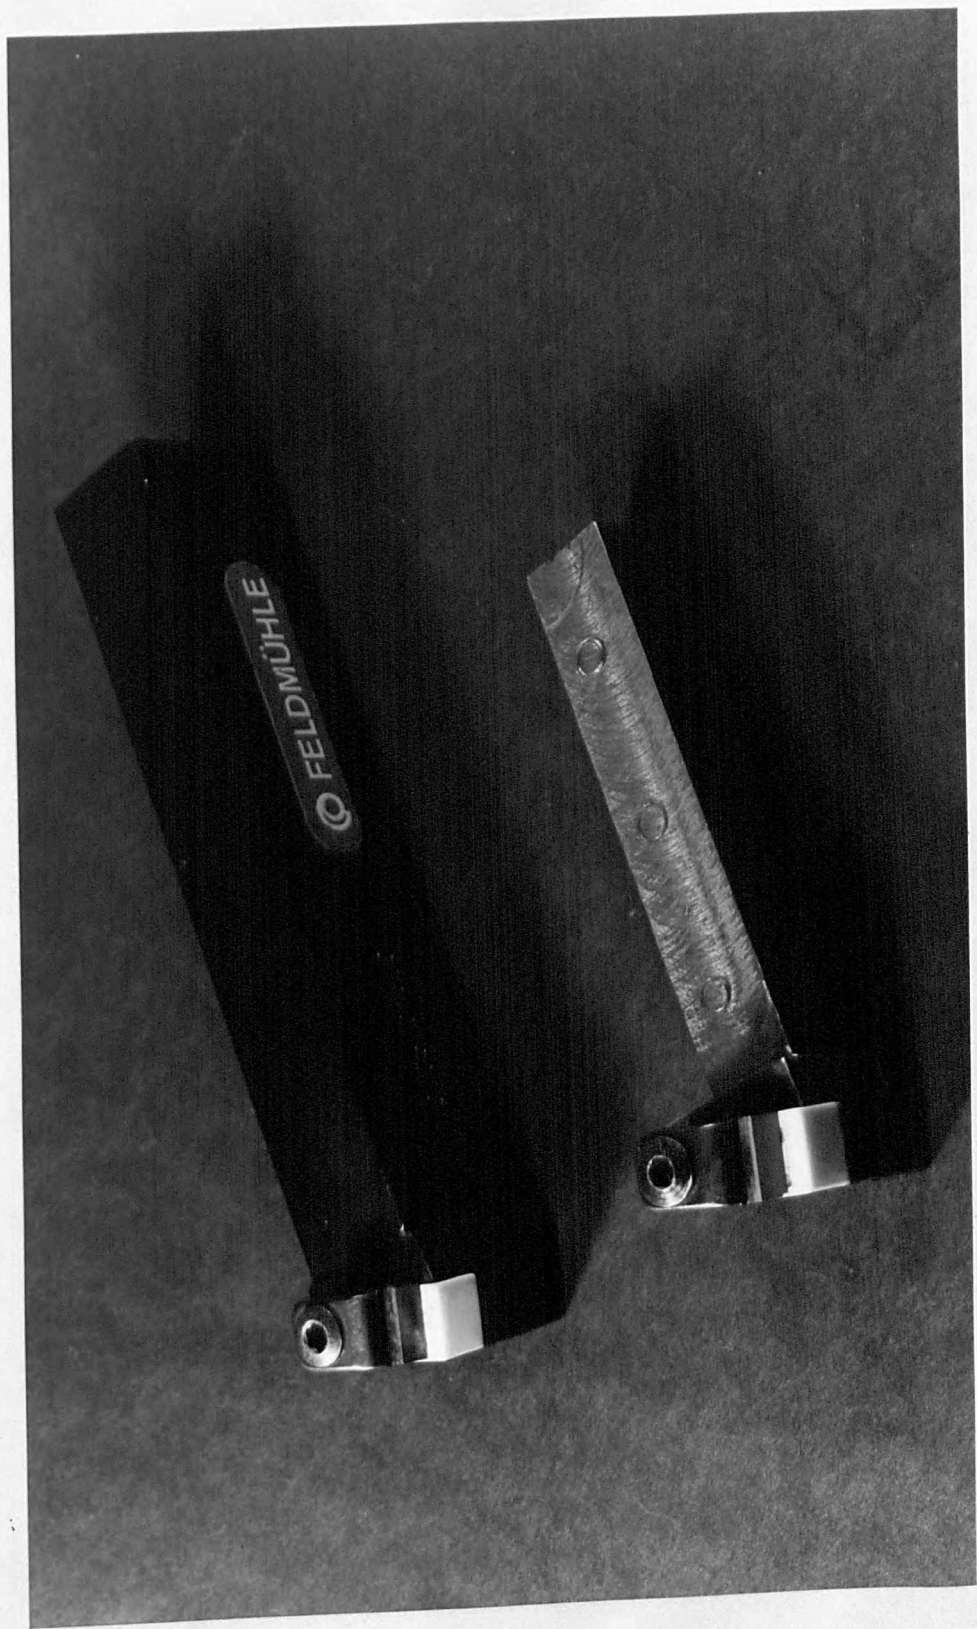
Fig.3.4.1. Duplicate tool holder reduced on shank to suit Mecalex dynamometer.

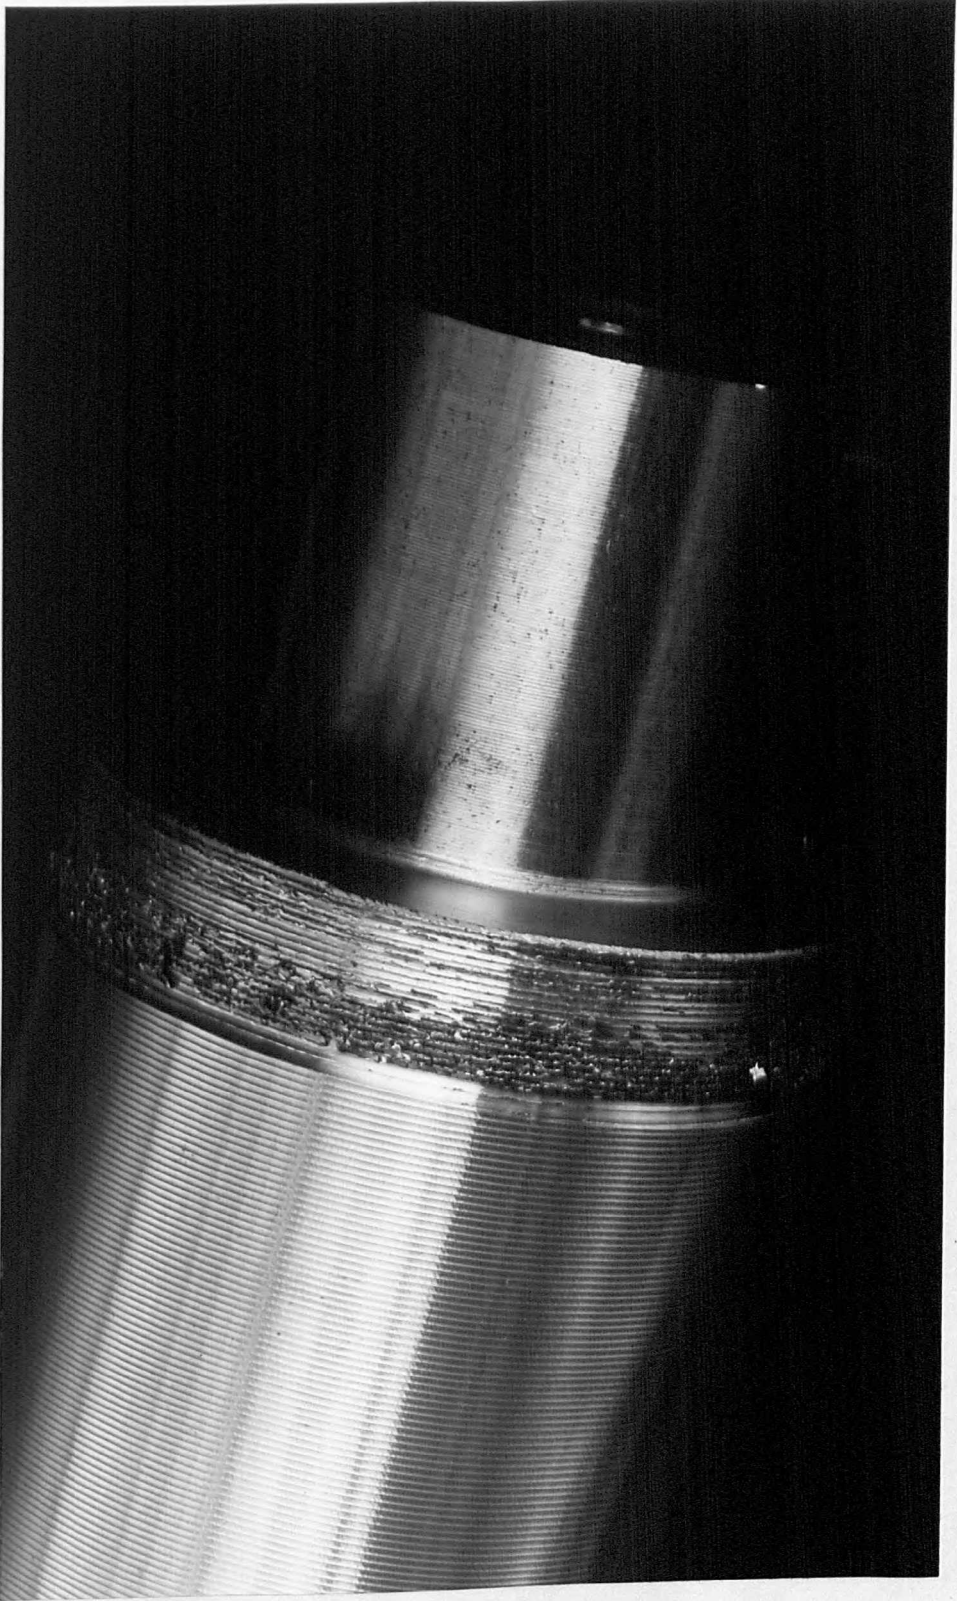
Fig.3.6.1. Illustration of re-engagement tool failure on test piece with feed rate of 0.028 in/rev at cutting speed of 1000 ft/min.

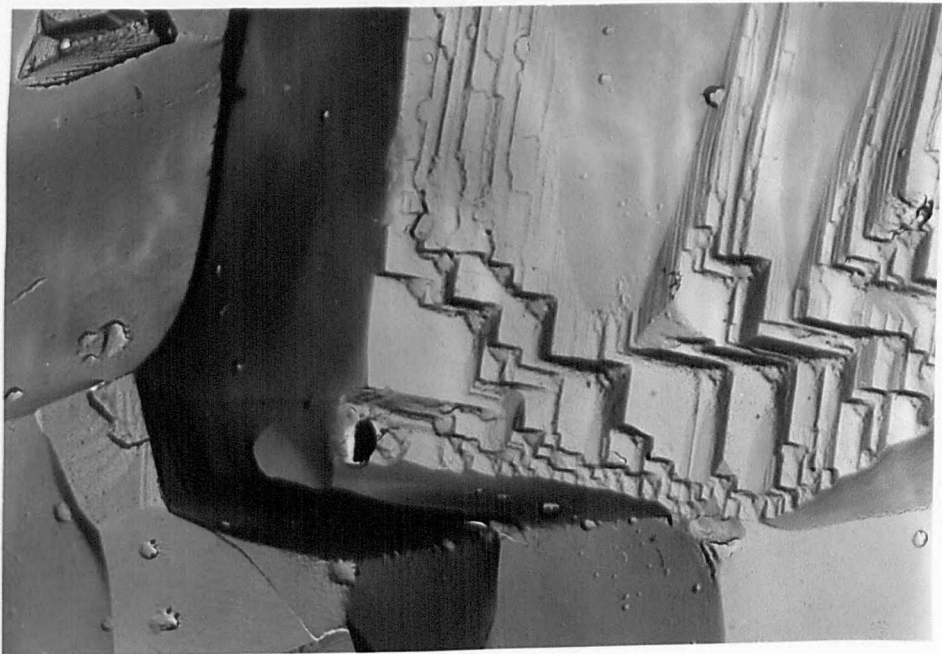
Fig.3.11.1. Micrographs of tool tip fracture surfaces. 8000X.
(a) Intergranular and transgranular fracture. (b) Porosity.

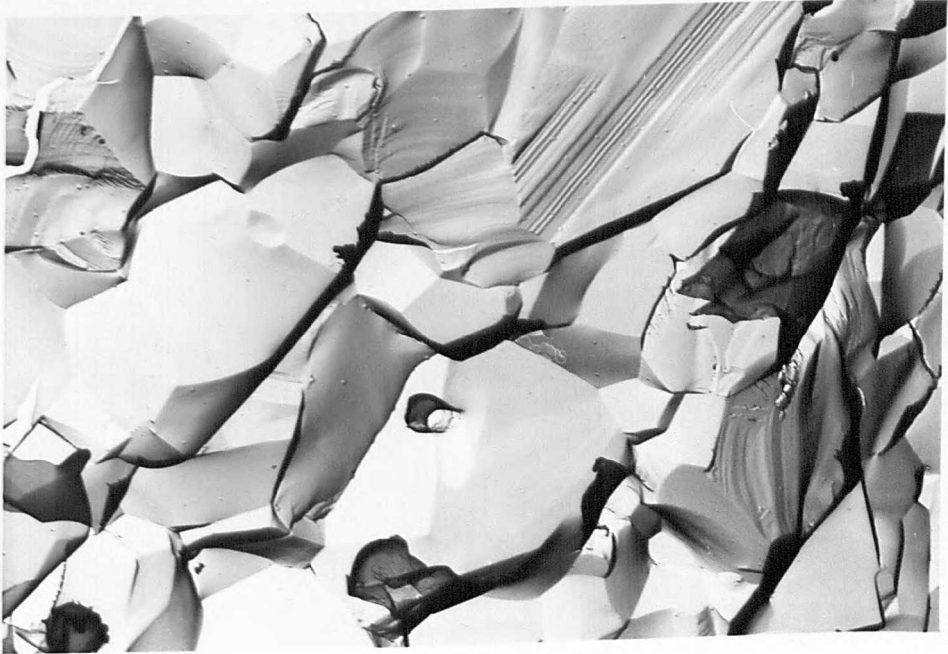
Fig.3.11.1. (g) Line of pores.20000X.
(h) Fracture surface.2500X.

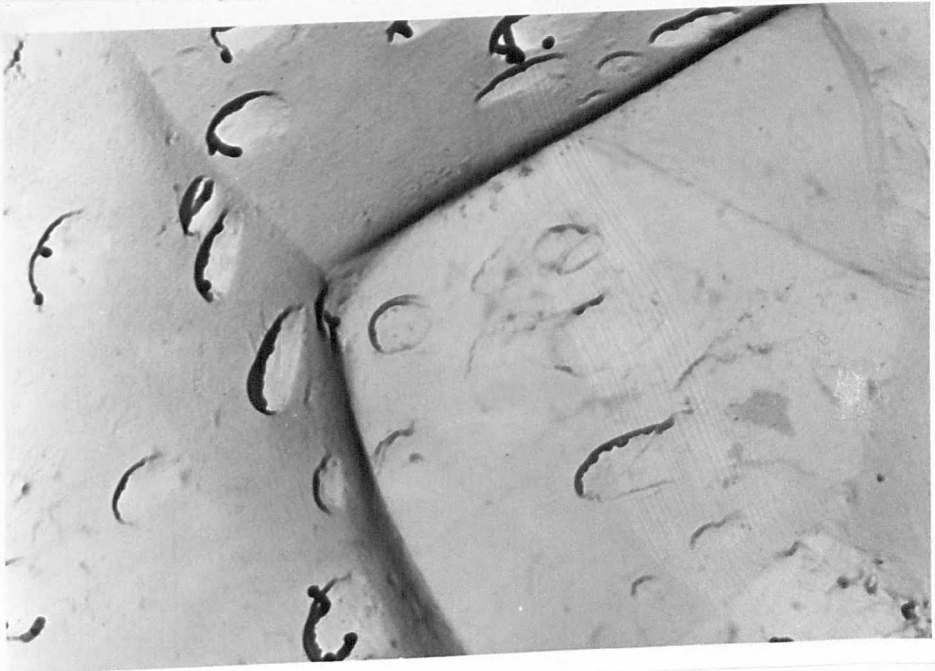
Fig.4.4(a) and (b). Showing random distribution of type 3 pore.
(a) in transgranular fracture surface.13000X.
(b) at grain boundaries. 10000X.
