# **Biodeterioration of cultural heritage monuments: A review of their deterioration mechanisms and conservation**

Geochemical cycles result in the chemical, physical, and mineralogical modification of rocks, ultimately leading to the formation of soil. However, when stones and rocks form part of historic buildings and monuments, the effects are deleterious. In addition, microorganisms colonize these monuments over time, resulting in the formation of biofilms, while microbial metabolites cause physical weakening and discoloration of the stone. This process, known as biodeterioration, results in a significant loss of cultural heritage. Purification and 16S rDNA sequencing of bacteria growing on heritage monuments revealed that the most prominent taxa were closely related to *Bacillus* spp., *Arthrobacter* spp., *Staphylococcus* spp. and *Paenibacillus* spp. In addition to bacteria, some fungal strains of the genera *Penicillium*, *Aspergillus*, *Fusarium* and *Alternaria* were also reported. To formulate effective conservation strategies to prevent biodeterioration and restore monuments, it is important to identify the microorganisms colonizing the substrate and the energy sources

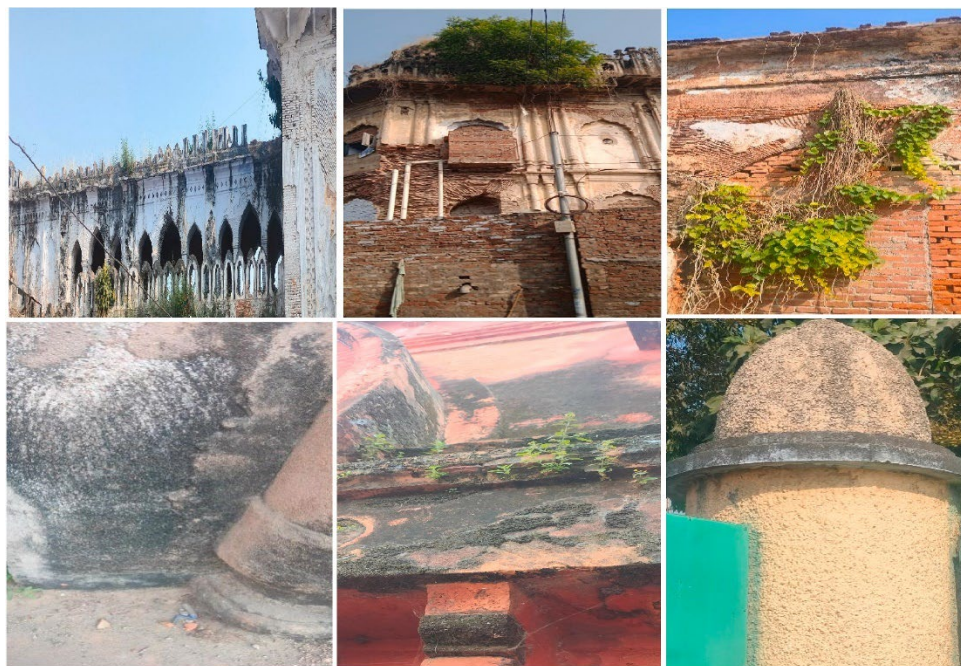
Fig. 1. Biofilms of cyanobacteria and algae accompanied by the growth of vascular plants on a brick wall of the cultural heritage.

Many different types of stone have been used for the construction of monuments over the years, with the most common ones being marble and limestone (calcareous type), sandstone (primarily composed of iron oxide, quartz, and feldspar) and granite (siliceous type). They differ in porosity, alkalinity and hardness which influence their susceptibility to biodeterioration to varying degrees. A depiction of monument's biodeterioration and its mechanism is shown in Fig. 1.

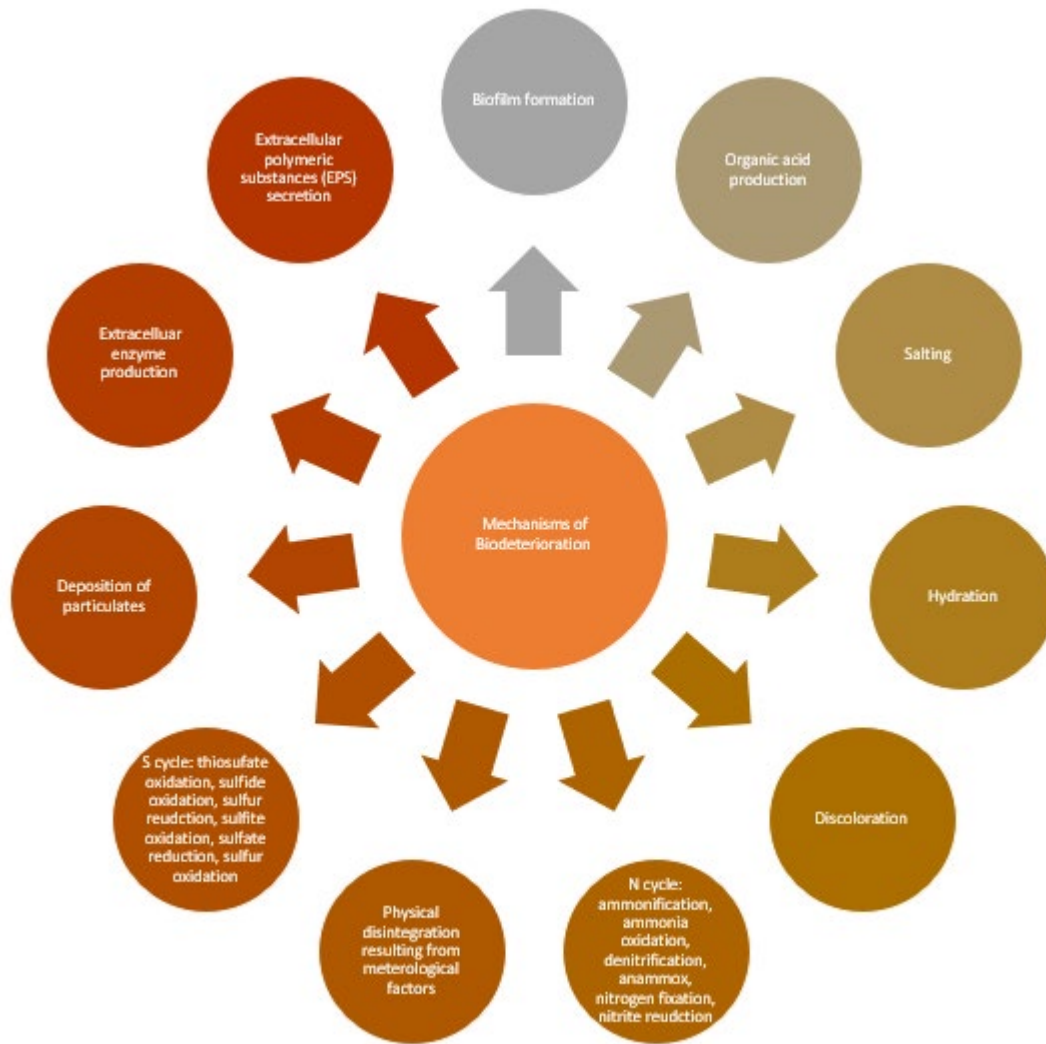
Fig. 2. A summary of biodeterioration mechanisms.

Lichens and fungi produce oxalic acid, which reacts with calcium carbonate in the stone to form calcium oxalate, resulting in colored patinas on the stone surface (Attiya and Jones, 2022; De Deckker, 2019). The two primary forms of calcium oxalate found in nature are weddellite ( $\text{CaC}_2\text{O}_4 \cdot 2\text{H}_2\text{O}$ ) and whewellite ( $\text{CaC}_2\text{O}_4 \cdot \text{H}_2\text{O}$ ). These compounds often appear as patinas on the stones of ancient monuments and artifacts. Raman spectroscopy has identified calcium oxalate dihydrate in lichens such as *Dirina massiliensis* f. *sorediata*, *D. massiliensis* f. *massiliensis* and *Tephromela atra* and calcium oxalate monohydrate in *Lecanora sulfurea* and *Aspicilia calcarea*. Additionally, historical stonemasonry treatments and air pollution are considered partial contributors to patina development. The mechanisms of biodeterioration and patina formation are shown in Fig. 2 and 3.

minerals, along with other polyols like glucose. The polyols present in these microbes protects them against freezing, desiccation, and excess salt by forming hydrogen-bond linkages with the polysiloxane crystals in the mica components. Microorganisms and mechanisms involved in the biodeterioration of monuments are shown in Table 1 and Fig. 2.
