The Exposure and Deterioration of Granitic Building Stone

William Booth Luxton

Urban Pollution Research Centre
Middlesex University

Submitted in partial fulfilment of the requirements of
Middlesex University for the degree of Doctor of Philosophy

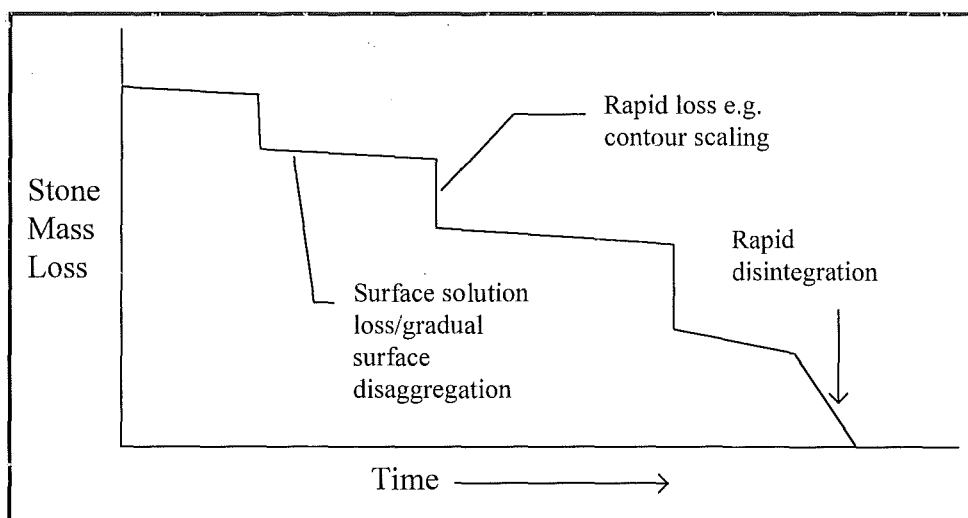
Figure 2.8. Mass loss from stonework during weathering (Smith *et al.*, 1992).

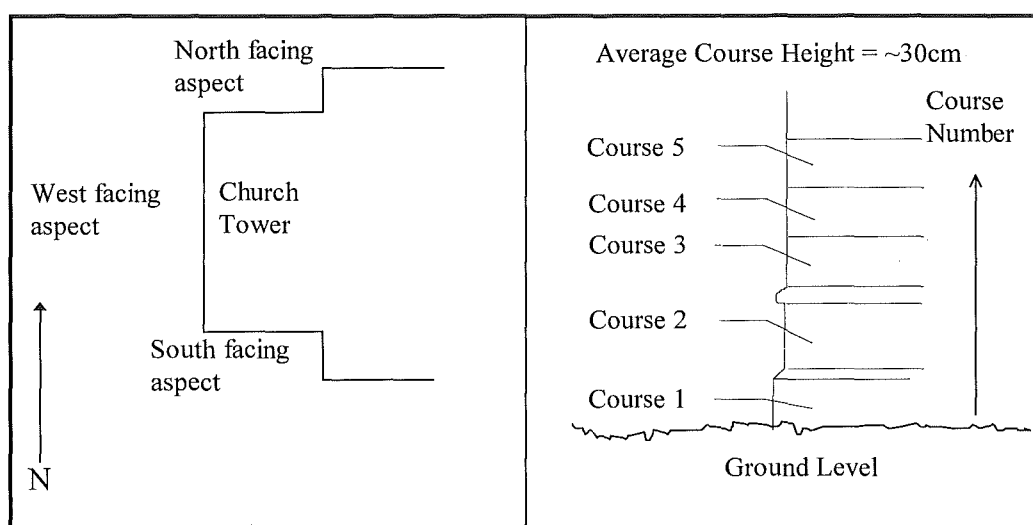
Figure 7.2. Generic tower and course position within churches.

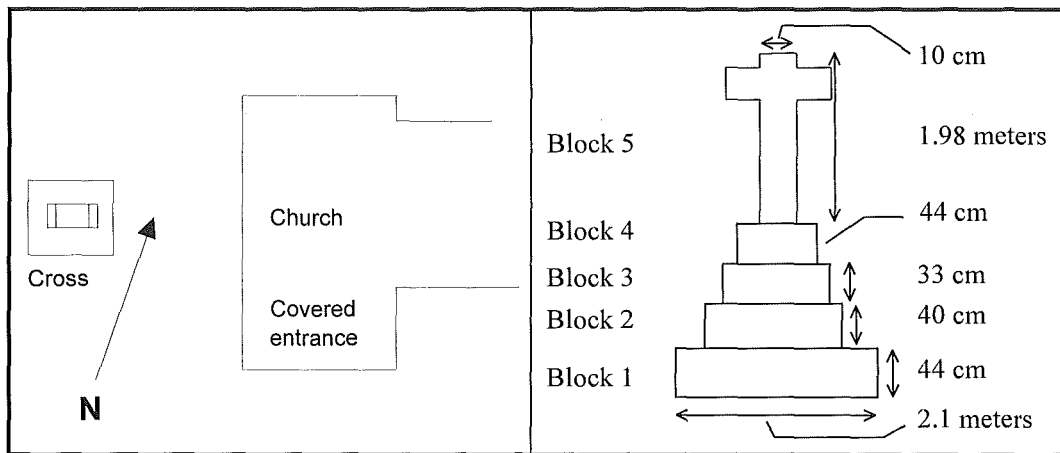
Figure 7.3. Orientation, position and dimensions of Luesdon cross.
