The low frequency corrosion fatigue performance of some surgical implant alloys: with reference to stress concentration, environmental factors and the behaviour of mild steel.

THE LOW FREQUENCY CORROSION FATIGUE PERFORMANCE  
OF SOME SURGICAL IMPLANT ALLOYS: WITH REFERENCE  
TO STRESS CONCENTRATION, ENVIRONMENTAL FACTORS,  
AND THE BEHAVIOUR OF MILD STEEL

THESIS

R.A. WHITAKER BSc MSc CEng MIMechE MRAeS

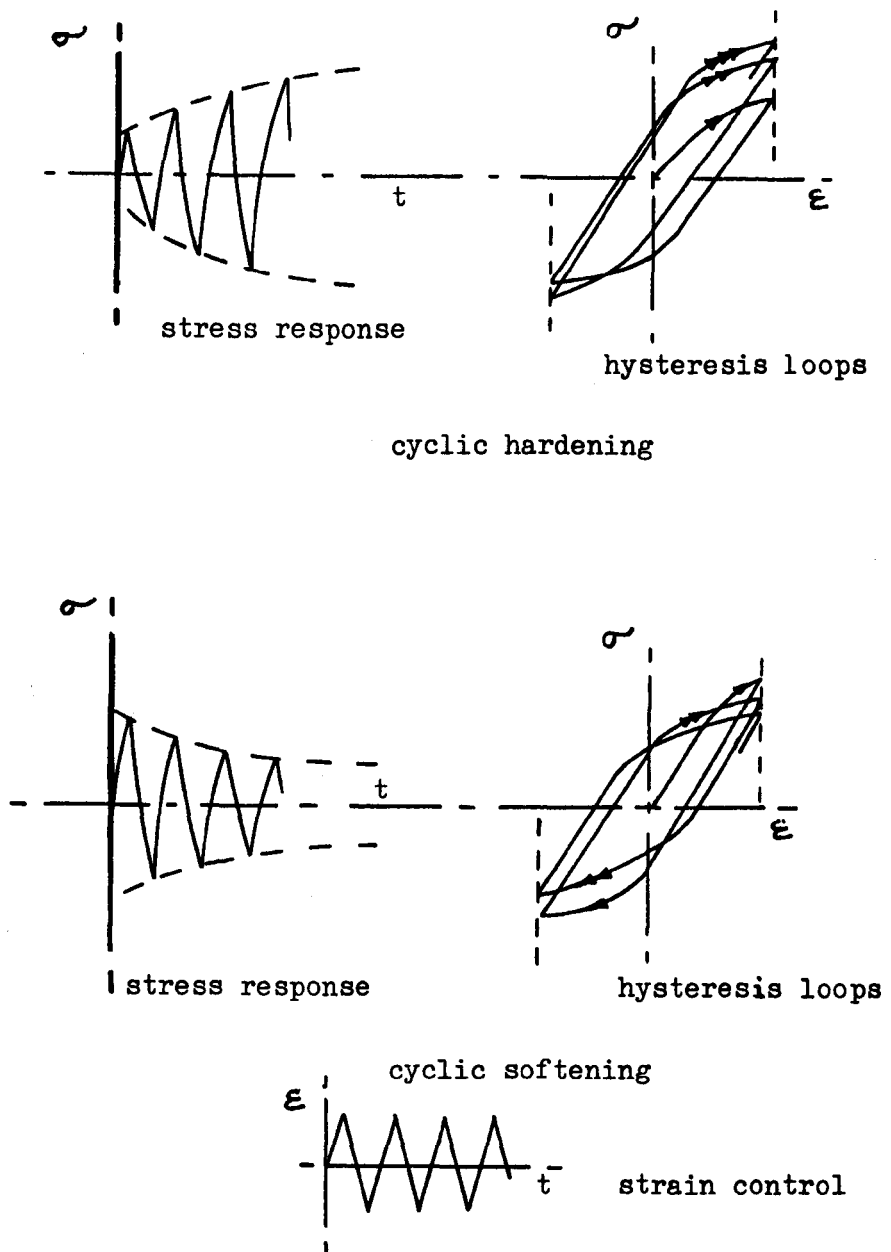
Figure R.8 Schematic representation of the response of metals to reversed strains.

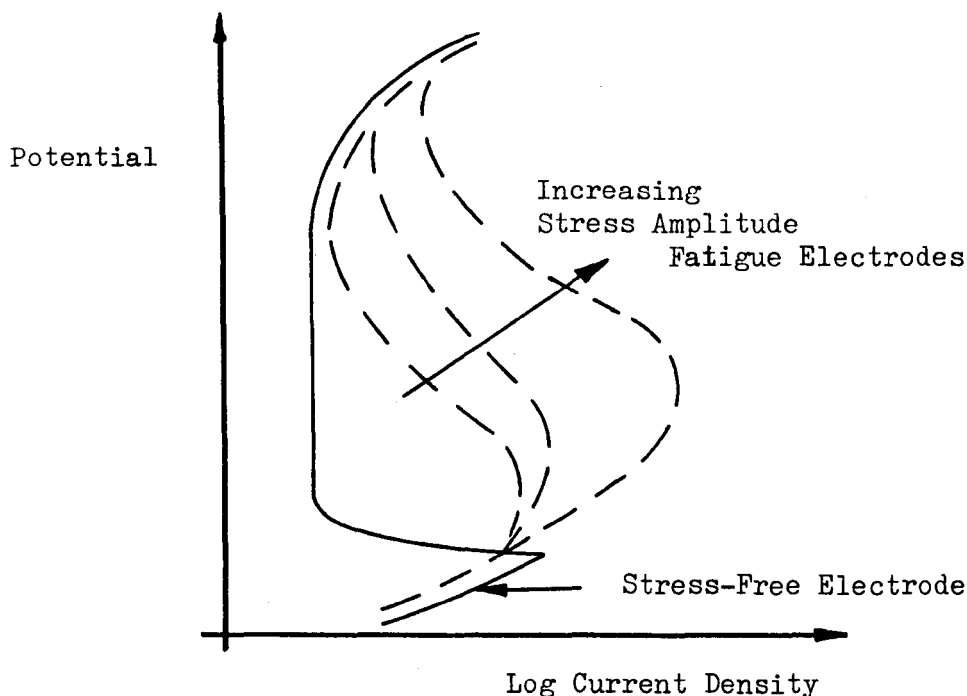
Figure R.12 Schematic anodic polarization curves for stress-free and fatigue loaded electrodes

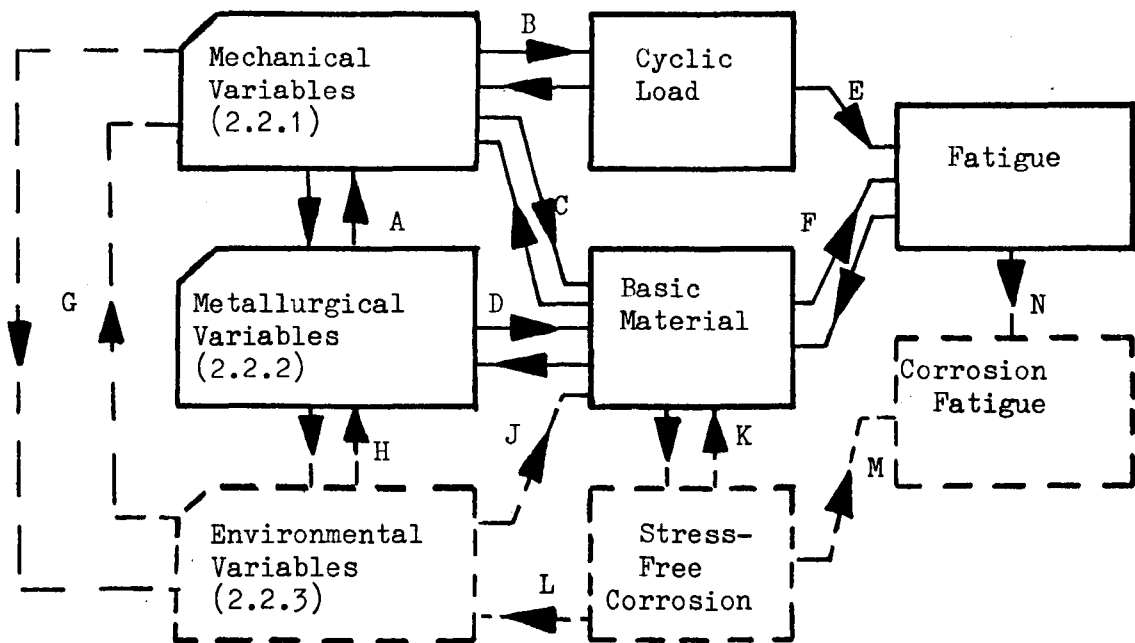
Figure R.16 A Systems Diagram Relating Interaction Paths  
In The Process of Corrosion Fatigue

A study of the variables discussed in section 2.6 together with the ways in which they have been found to inter-relate in the process of corrosion fatigue is most valuable in the formulation of possible mechanisms. Fig. R.16 is an attempt by the author to correlate these variables on a systems-type diagram. The boxes and lines shown in full illustrate the inert environment situation: mechanical and metallurgical variable factors interact with each other ('A'), as the result of forward path and feedback (indicated by double lines and arrows); the inter-action of 'cyclic load' and the 'basic material' (paths 'E' and 'F') result in 'fatigue', which causes changes in the basic material (feedback path 'F'); further feedback paths indicate resultant changes in metallurgical variables ('D'), mechanical variables ('C'), and cyclic load ('B'). The boxes and lines, shown dashed, together with the diagram in full lines (as discussed above)

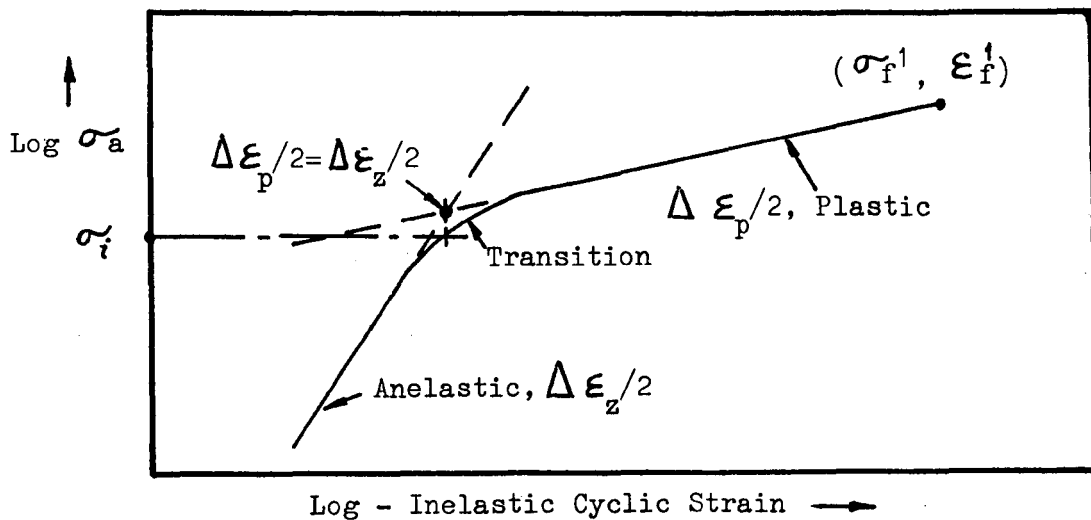
Figure R.19 Variation of inelastic cyclic strain with stress amplitude (after Feltner and Morrow<sup>166</sup>)

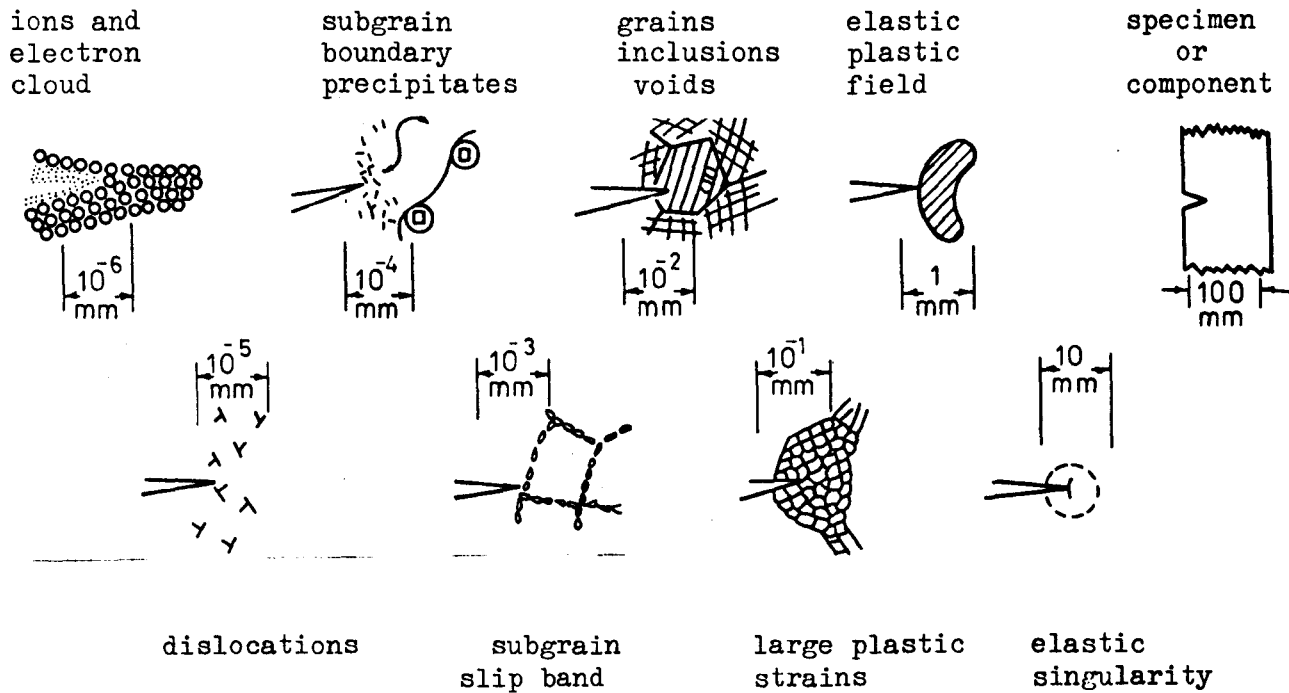
Figure R.21 Schematic Illustrations of Fracture when viewed at Different Scales (After Pook<sup>47</sup>)
